FABCO INDUSTRIES, INC
STORMWATER NUTRIENTS: P & N
TEST PROGRAM

Executive Summary

Under a contract between a local municipality and Fabco Industries, Inc, Bohemia, NY, from October 2006 to December 2007 a series of field tests were conducted on the Fabco StormBasin and StormPod catch basin inserts to evaluate their effectiveness in reducing phosphorus and nitrogen compounds in stormwater runoff. The testing took place at 3 different sites and involved 5 different filter cartridge configurations.

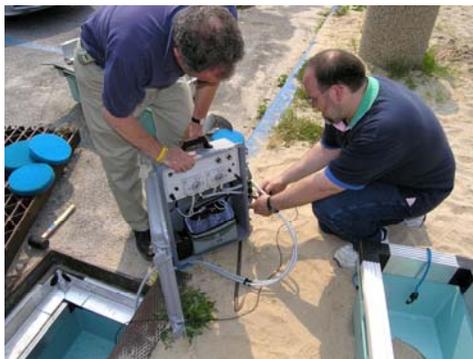
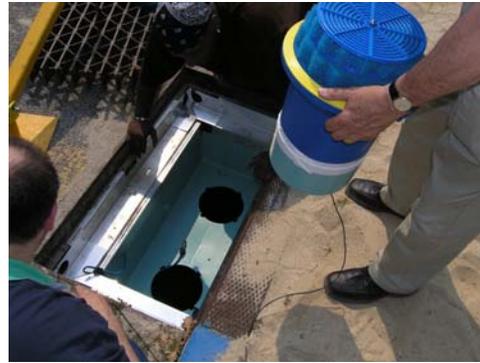
To collect the effluent samples special collection “pails” or “buckets” were designed to attach and seal directly to the bottom of the standard Fabco Cartridge body.

In the pictures on the right, the standard cartridge body is dark blue. The collection pail area is a light green color and is sealed to the cartridge body with a sealing adhesive.

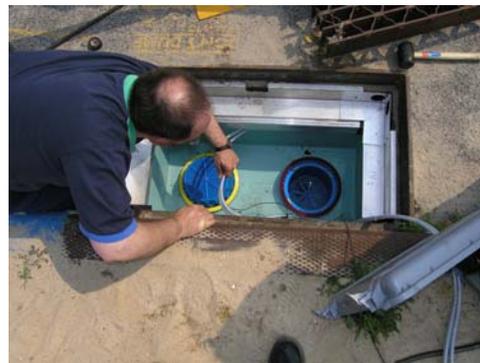
- 1) A vertical over-flow pipe – To maintain approximately 2 liters of water in the pail while allowing excess water to escape.
- 2) A quick connect coupling – Connects pail to the supply line of the peristaltic pump and sample bottle.
- 3) A sensor switch - Activates pumps when the minimum level of water has accumulated in the pail.

Two collection pails were fabricated. The first was attached to the standard Fabco filtering cartridge under test. The second was attached to an empty cartridge body. These two filters were then installed into the bottom of the StormBasin unit with the supply lines routed to the Global Sampler.

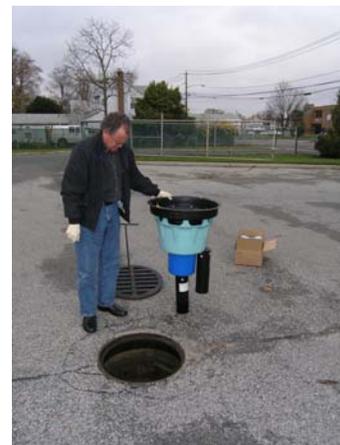
The Nalgene sampler assembly consists of a round black mounting tube and a translucent one liter, plastic sampling bottle that is inserted down into the mounting tube.

Two samplers were used per unit; one was attached to the plastic collection tub and a second was attached to the bottom of the cartridge.

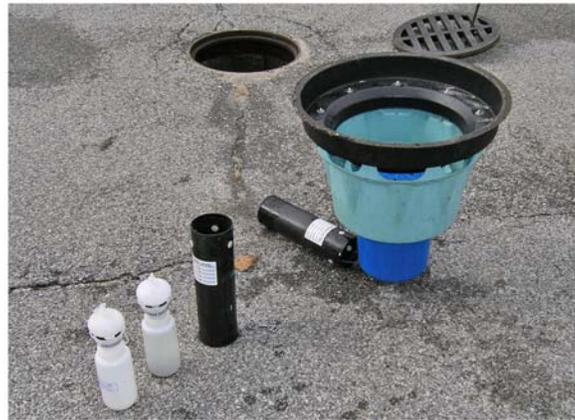
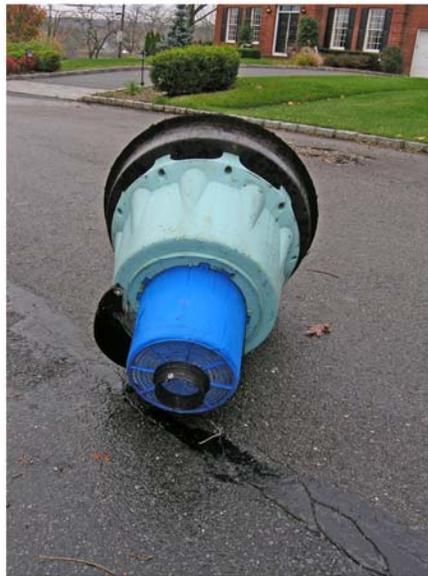
The black Nalgene tubes were mounted vertically (extending downwards) from the bottom of the StormPod basin and filter cartridge using clevis pins so that they could be removed when required.

After completing these preparatory steps the white sample bottles were then inserted into the mounting tubes and the assembly was fixed, using the clevis pins, to the StormPod basin and cartridge body. In this configuration the bottle under the Basin would collect the sample of untreated water whereas the bottle under the cartridge would catch a sample of treated water.
